COMMERCIAL WINDSTORM MITIGATION INSPECTION REPORT (OIR-B1-1802)

Pine Run Association, Inc.
751-767 Pine Run Dr, Building G
Sarasota, FL 34229

As of 4/18/2017

RECAPITULATION OF MITIGATION FEATURES
For 751-767 Pine Run Dr, Building G

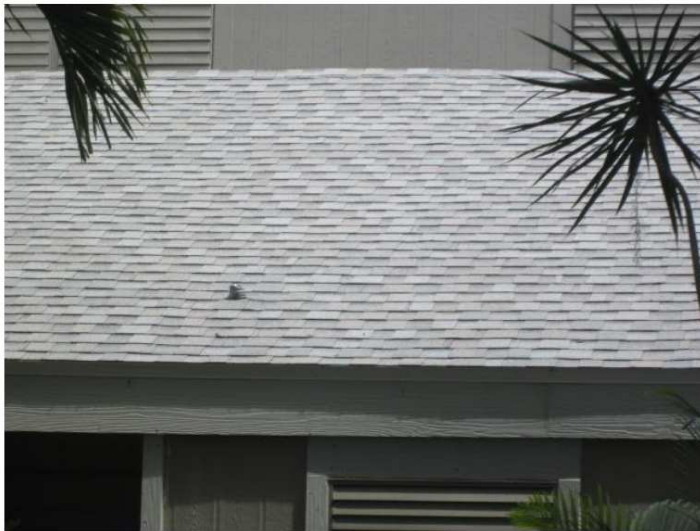
Roof Construction

- 3. Roof Deck Attachment:** **Level C**
Comments: Inspection verified 1/2" plywood roof deck attached with 8d nails at a minimum 6" on the edge & 6" in the field.

- 4. Roof to Wall Attachment:** **Clips**
Comments: Inspection verified hurricane clips fastened with a minimum of three nails.
- 5. Roof Geometry:** **Other Roof**
Comments: Inspection verified a gable roof shape.
